XENON LAMPS

XENON HEADLAMP BULB REPLACEMENT

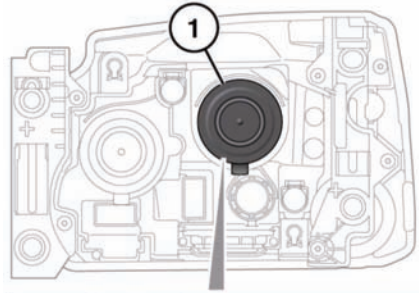
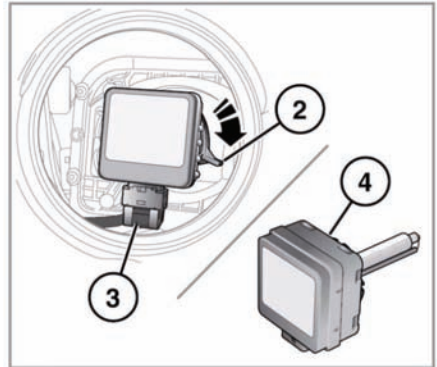
E135155

- Twist and lift off the domed cap.
- Rotate the collar securing the bulb to the lamp and release the bulb.
- Pull off the electrical connector and remove bulb unit.
- Insert the new bulb unit and reverse the above procedure. Ensure that the lugs on the cap are in contact with the bulb base.
