## XENON LAMPS

## XENON HEADLAMP BULB REPLACEMENT

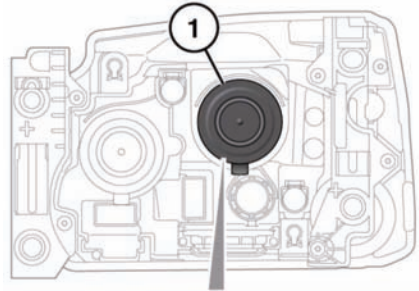
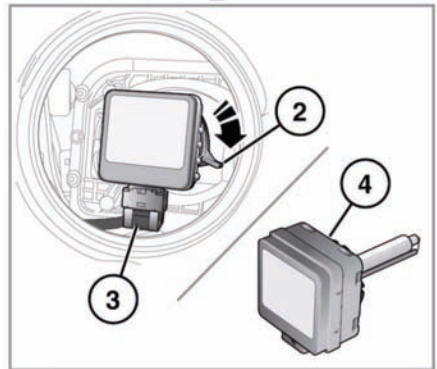
E135155

1. Twist and lift off the domed cap.
2. Rotate the collar securing the bulb to the lamp and release the bulb.
3. Pull off the electrical connector and remove bulb unit.
4. Insert the new bulb unit and reverse the above procedure. Ensure that the lugs on the cap are in contact with the bulb base.
