CONTROLS AND DISPLAY

Controls and display

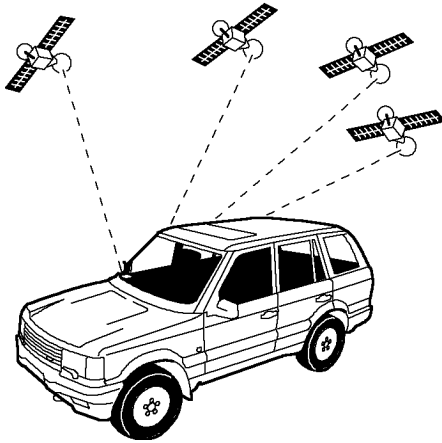
Unfavourable satellite alignment in conjunction with the incorrect positioning of the GPS antenna may give bad signal reception over longer periods.

If the GPS antenna has been properly installed, GPS reception should be available for about 95 % of driving time. If regular interference in reception occurs, incorrect mounting of the GPS antenna may be the cause. If this is the case, we recommend you to contact your nearest Land Rover dealer.
