Maintenance

UNDER BONNET COVERS

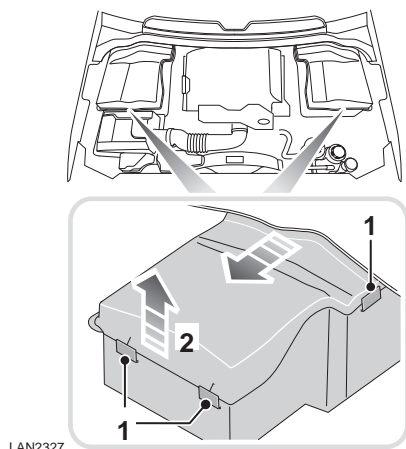
1. Press the tabs to release the cover from the casing.

Note: *Releasing the inboard tab on the front edge of the cover first will make it easier to release the other tabs.*

2. Lift the front edge of the cover and slide forwards to remove.

1. Slide the rear edge of the cover under the rubber trim fitted to the scuttle panel.
2. Make sure the front edge of the cover is flush to the casing and then press down until the tabs click into place.
