DIRECTION INDICATOR BULB REPLACEMENT

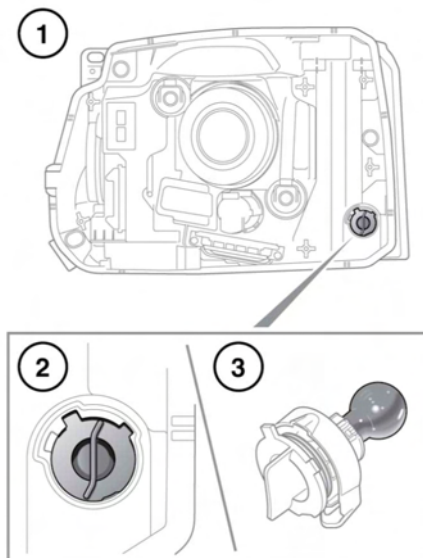
E156703

1. Rotate the bulb holder 45 degrees anticlockwise.
2. Rotate to remove the bulb assembly from the lamp.
3. Push and twist to remove the bulb.

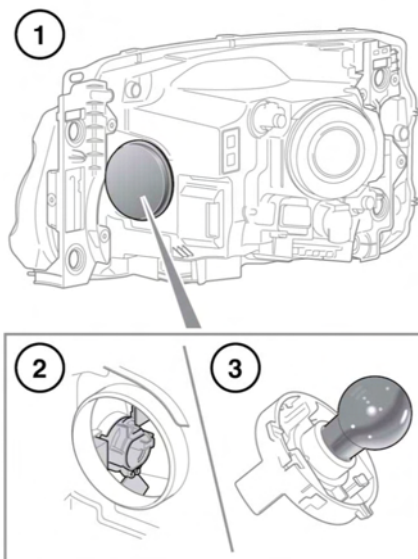
E156737

1. Twist and lift off domed cap.
2. Pull off the electrical connector and remove the bulb assembly.
3. Push and twist to remove the bulb.
