DIRECTION INDICATOR BULB REPLACEMENT

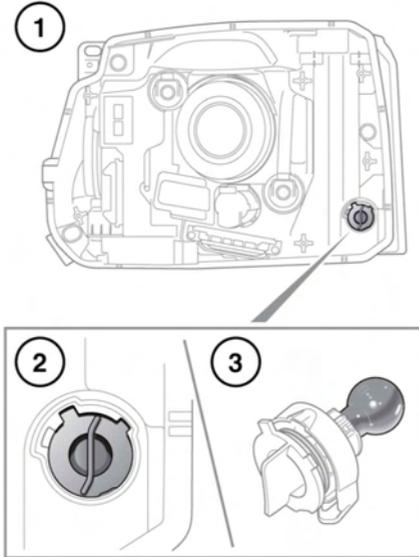
E156703

Note: The direction indicator bulb location is dependent on the vehicle specification.

1. Rotate the bulb holder 45 degrees anticlockwise.
2. Rotate to remove the bulb assembly from the lamp.
3. Push and twist to remove the bulb.

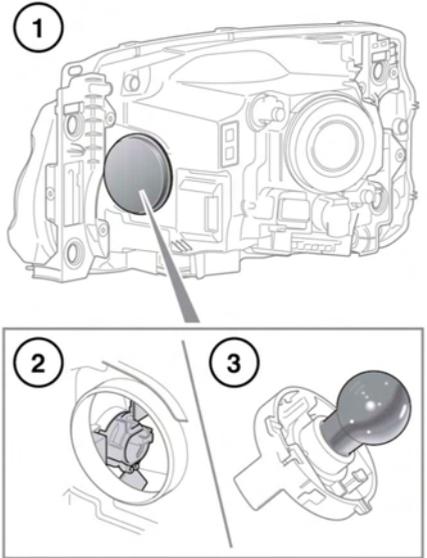
E156737

1. Twist and lift off domed cap.
2. Pull off the electrical connector and remove the bulb assembly.
3. Push and twist to remove the bulb.
